Reducing Slips, Trips, and Falls in the Maritime Industry and Offshore Installations -Best Practice

Master Thesis M.Sc. in Risk and Safety Management

Tanja Rasmussen

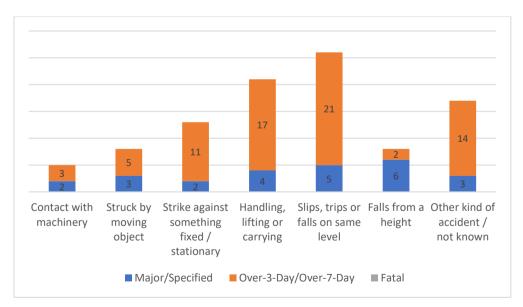
Figure 1: Reported injuries (offshore) by kind of accident in 2019. Source: (Health and Safety Executive, 2020)

As seen in figure 1, slips, trips, or falls on the same level accounted for 26,5% of all reported injuries. Besides, falls from height accounted for 8% of all reported injuries. Thus, in total, slip, trip, or falls on the same level and falls from a height are responsible for 34,5% of all reported injuries in the UK that occurred in offshore installations. From them, 67,6% were over-3-day/over-7-day injuries, and 32,4% were major/specified injuries (Health and Safety Executive, 2020).

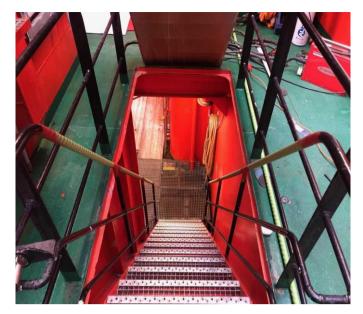
Figure 5: Staircase with existing handrails and stair treads without anti-slip covers. Source: Author

In order to find the reason behind the scratches of a leg, the stair dimensions such as the height of the rise and the depth of the stair tread were measured. These dimensions were found to be within legislative requirements. A more detailed investigation was not possible due to the project's limited time. The author assumes that the reason behind these incidents is the human's walking habits.

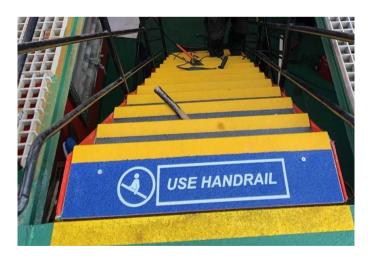
The anti-slip solutions are products for any surface that provide high friction in any environment and weather. Different companies on the market deliver anti-slip products, but this project considers the anti-slip solutions from Real Safety. Real Safety is located in Esbjerg (Denmark). Real Safety anti-slip solutions can be non-slip on virtually all surfaces, and these products are non-slip whatever the environment and weather. Real Safety can offer non-slip solutions on wood, steel plates, steel gratings, concrete, and tiles surfaces. These solutions can be applied for stairs, steps, walkways, ship decks, platforms, platforms, terraces, etc. The COF of Real Safety anti-slip covers, tested in wet conditions, is 0.95 (Appendix 1: Electronic Interviews).

Figure 16: Real Safety anti-slip stair tread covers at Danish ship. Source: Author

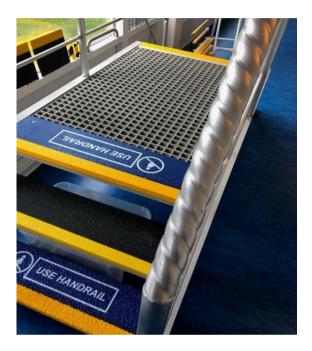
The KAG safety rails are presented in Denmark by Acurail, which is located in Esbjerg. The KAG safety rails can be manufactured from stainless steel, black steel, copper, aluminum, and

brass and are designed to afford increased grip levels to the user compared to plain tube handrails. The KAG rails give up to 300% better grip during oily conditions, up to 160% during dry conditions, and 80% under wet conditions than conventional products on the market. The KAG rails suitable for a wide range of premises and environments aimed to prevent accidents, injuries, and muscle strains while increasing comfort and ease (Pellegrin) (Appendix 1: Electronic Interviews).

Figure 17: Formed KAG handrail sample. Source: (Appendix 1: Electronic Interviews).

Acurail: The Acurail is a company located in Esbjerg (Denmark) that provide the KAG safety rails, formed from stainless steel, black steel, copper, aluminum, or brass tubing, with a broad range of safety measures that can be applied in any environment. The unique wavy profile maximizes handgrip on ladders, work platforms, stairs, walkways, grab and shower rails in all conditions. The company aims to reduce the risk of STF accidents and related injuries (Appendix 1: Electronic Interviews).
